United States Fire Administration

Technical Report Series

The East Bay Hills Fire Oakland-Berkeley, California

Investigated by: J. Gordon Routley

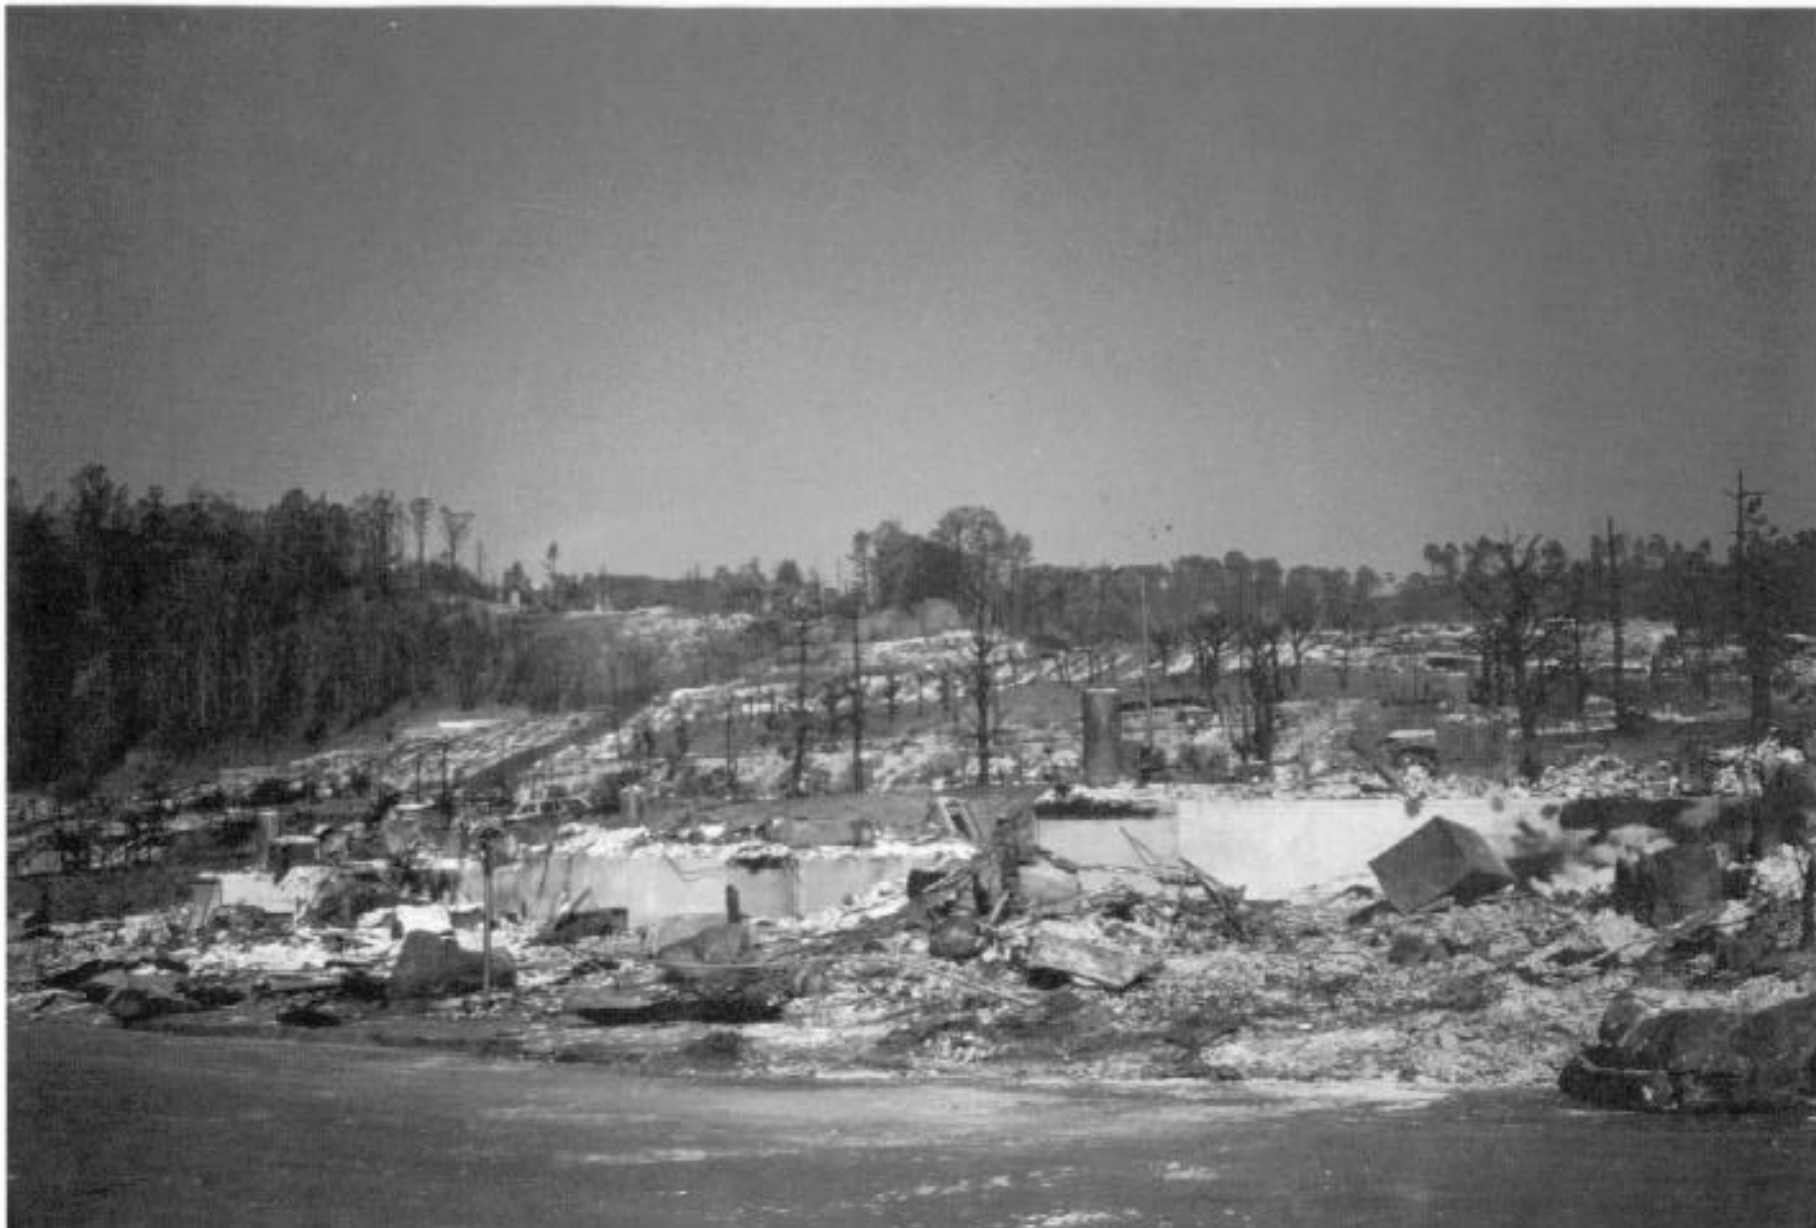
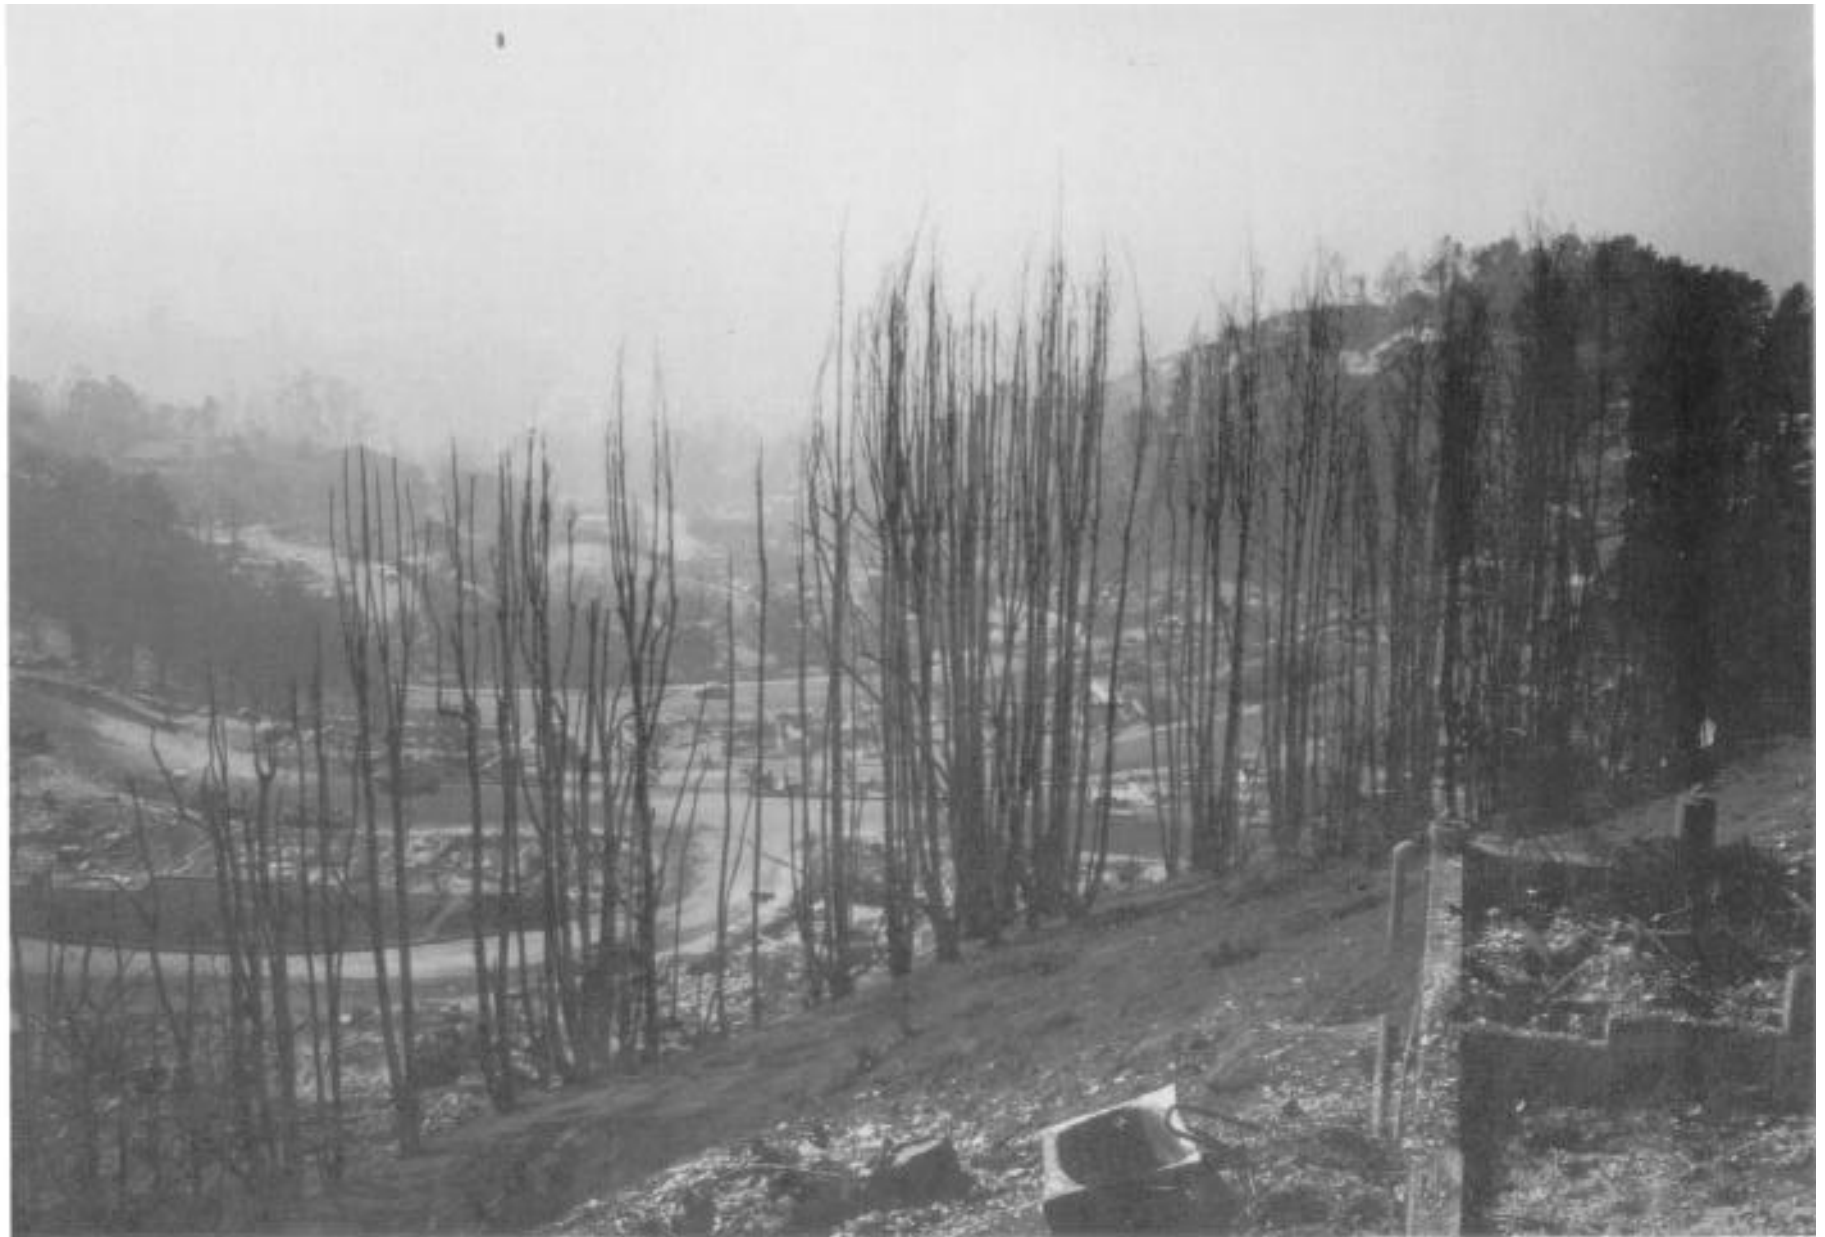
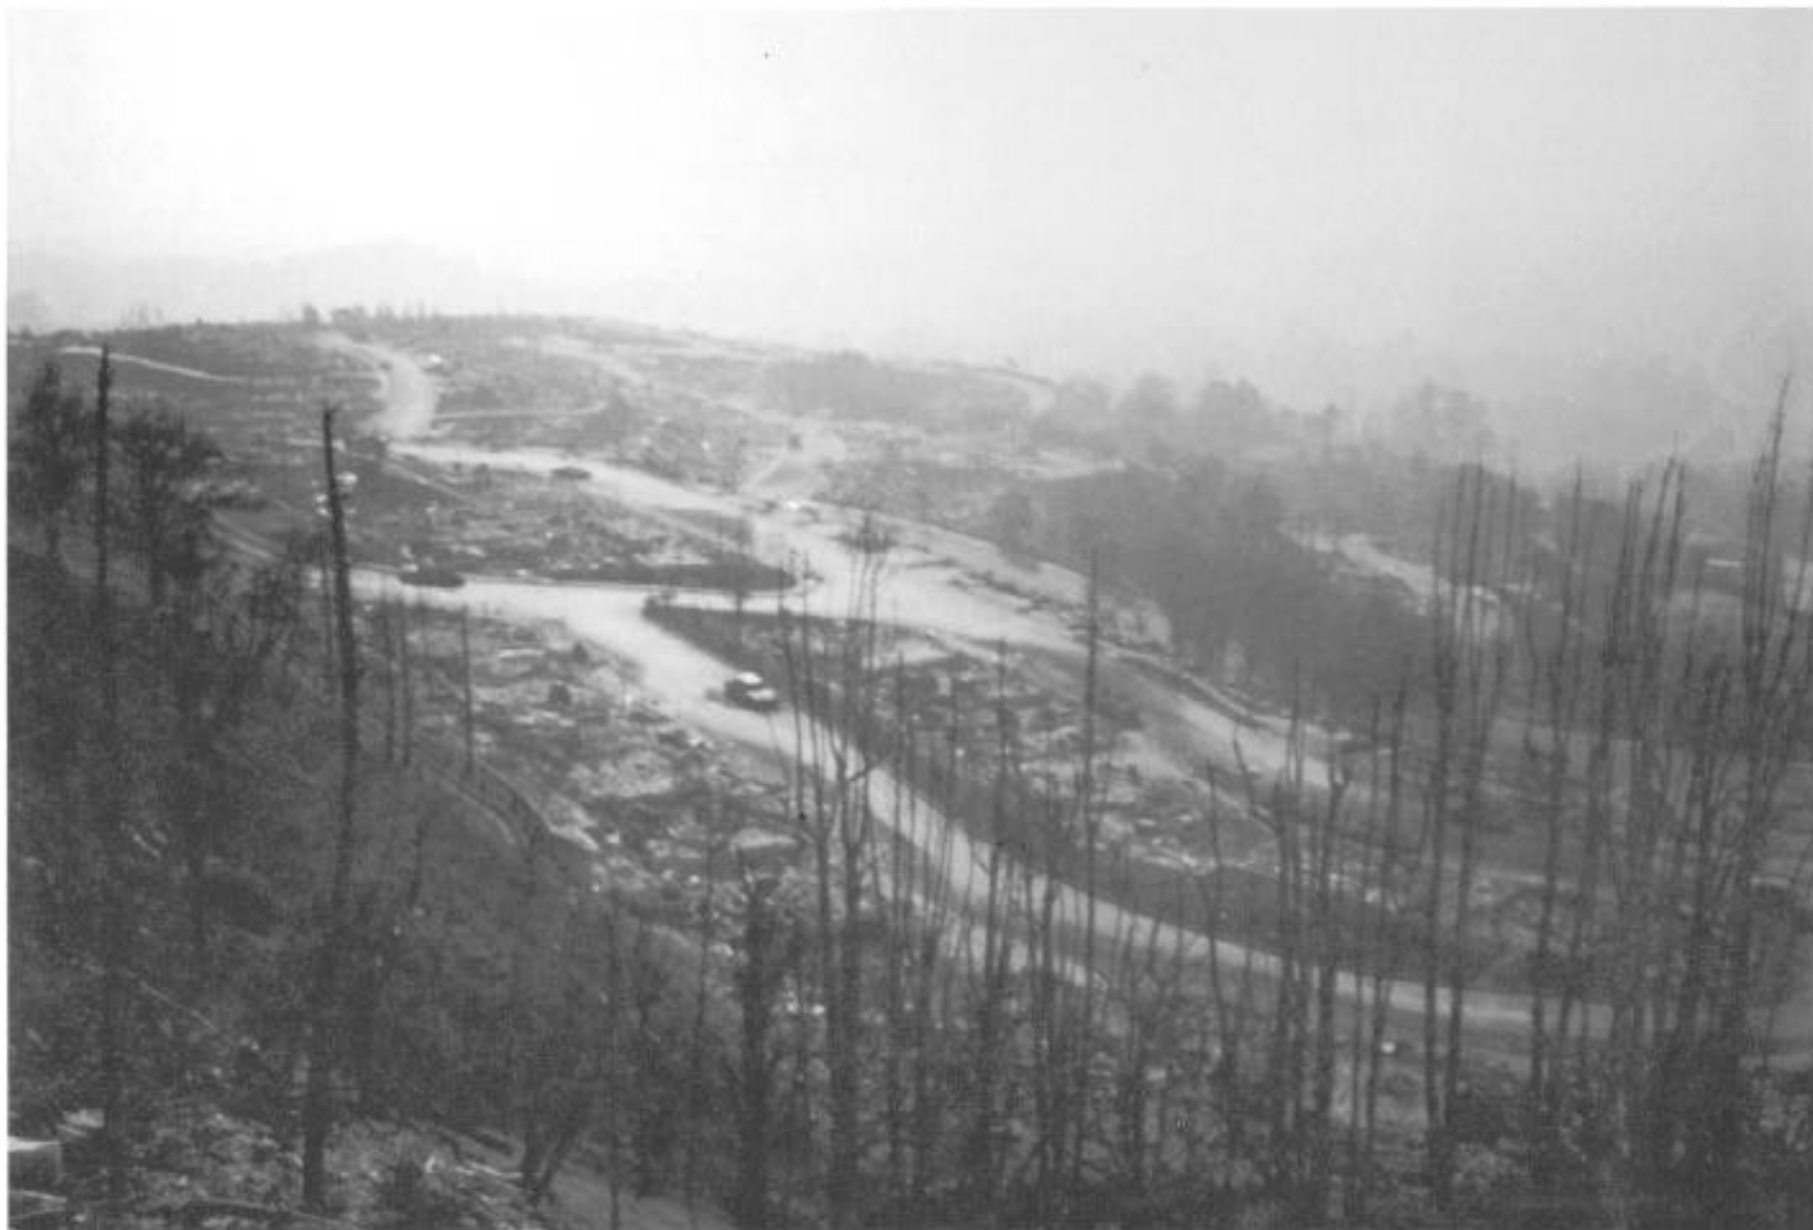
Total destruction of Hiller Highlands complex.

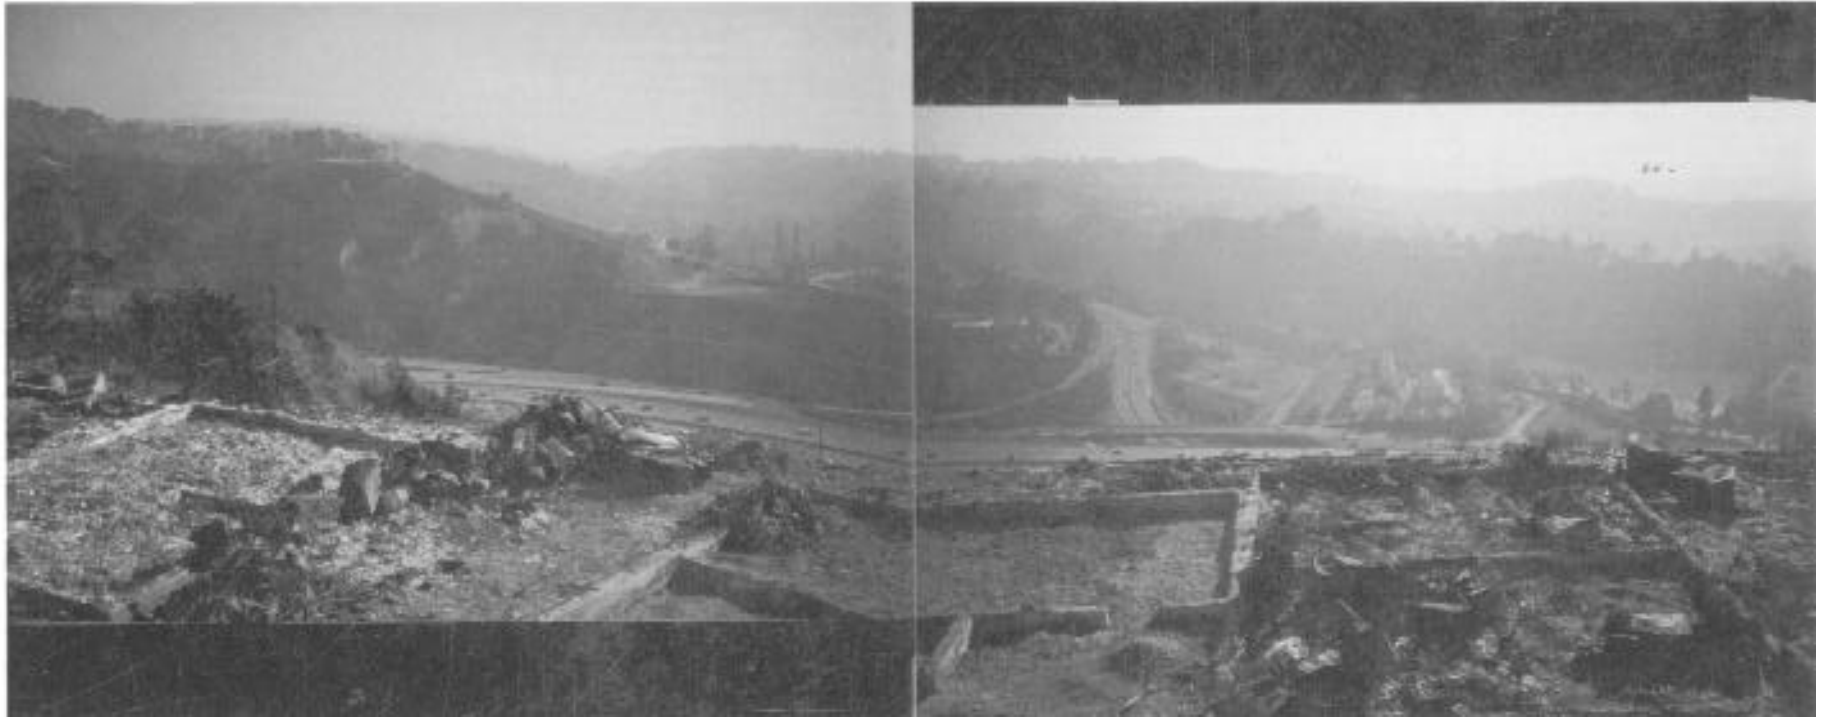
View from Hiller Highlands, looking down on interchange of Highway 24 and Highway 13. Entrance to Caldecott Tunnel is to the left. Lake Temescal and Rockridge District in the background. Fire jumped from Hiller Highlands to the trees beyond Lake Temescal, a distance of approximately 2,000 feet.

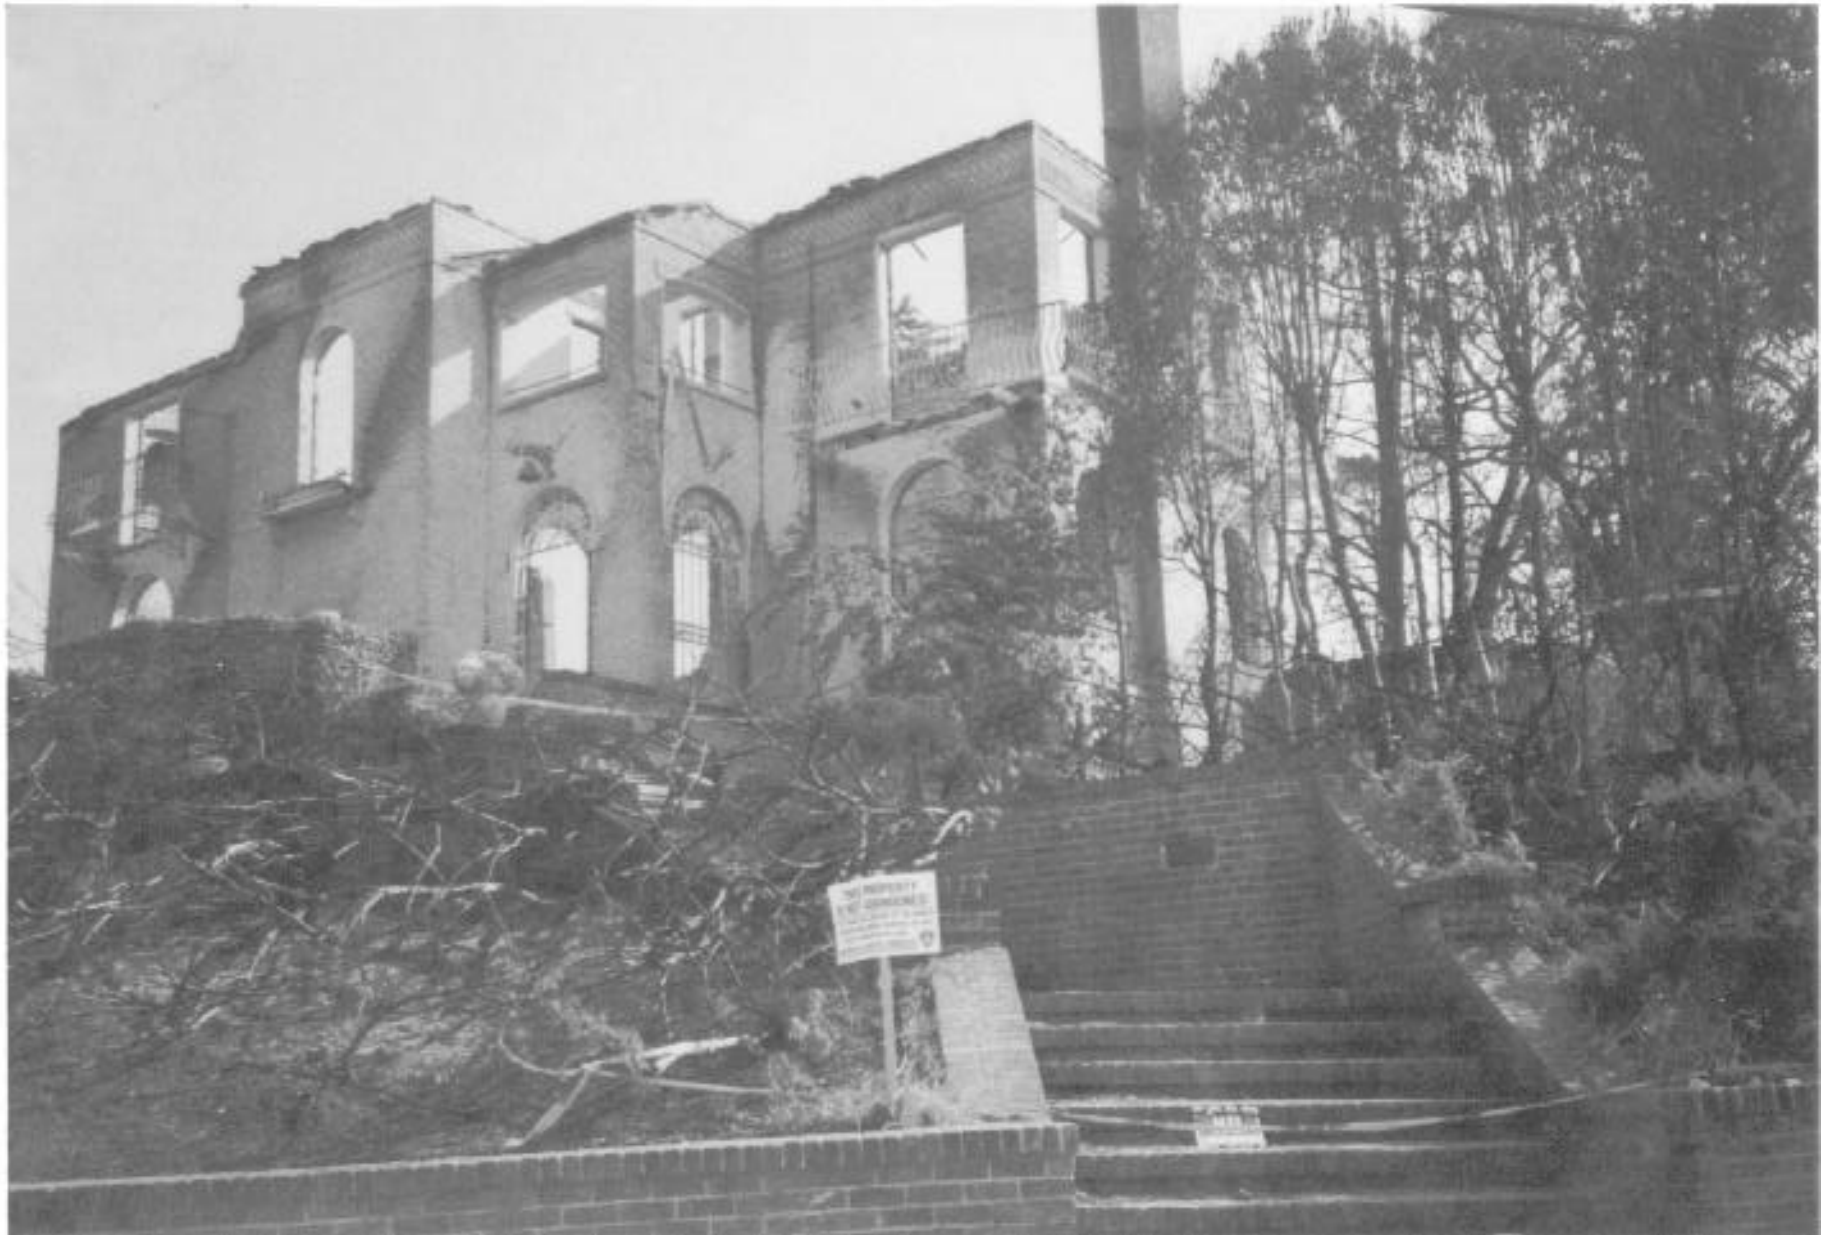
Ruins of large 2-story home in Rockridge district.

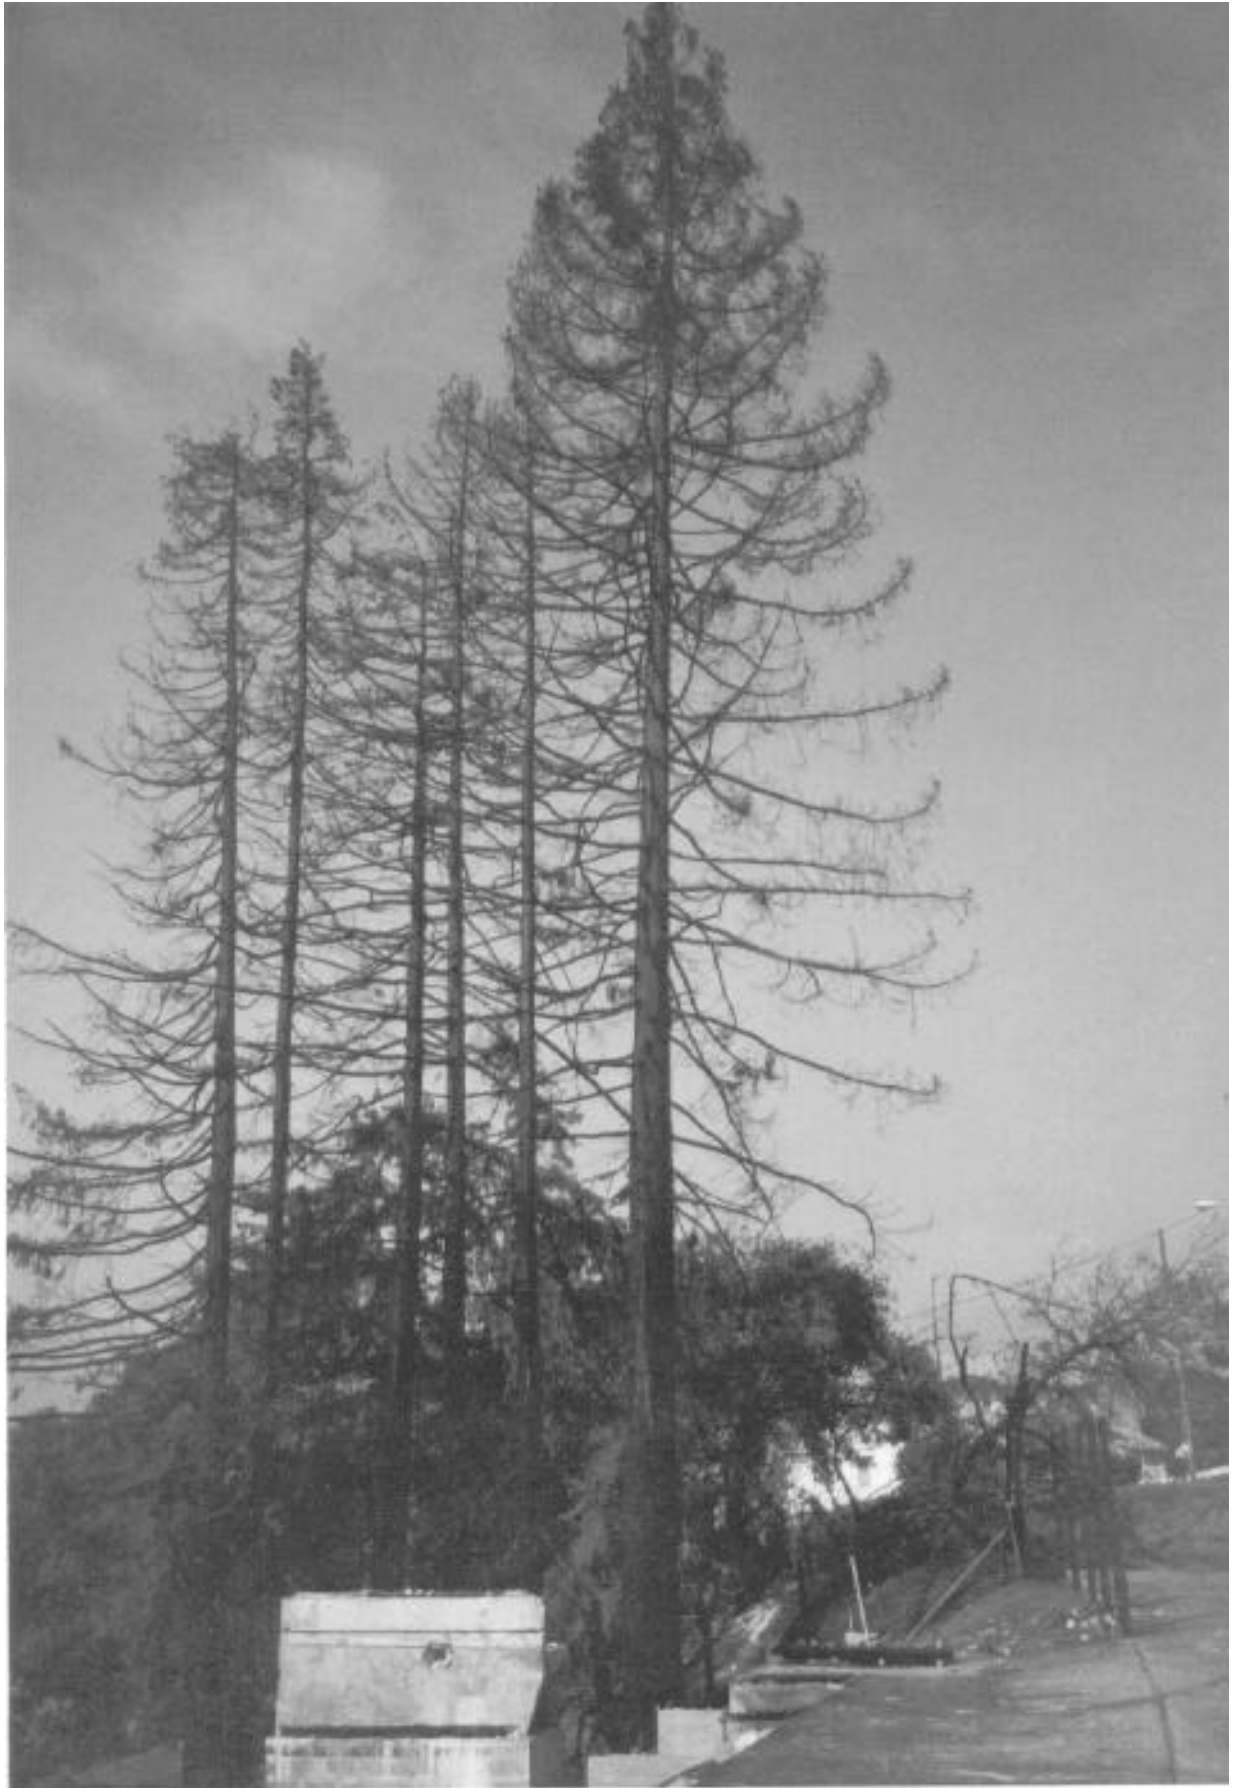
Huge pine trees in the Rockridge district ignited and accelerated the fire spread in this area.

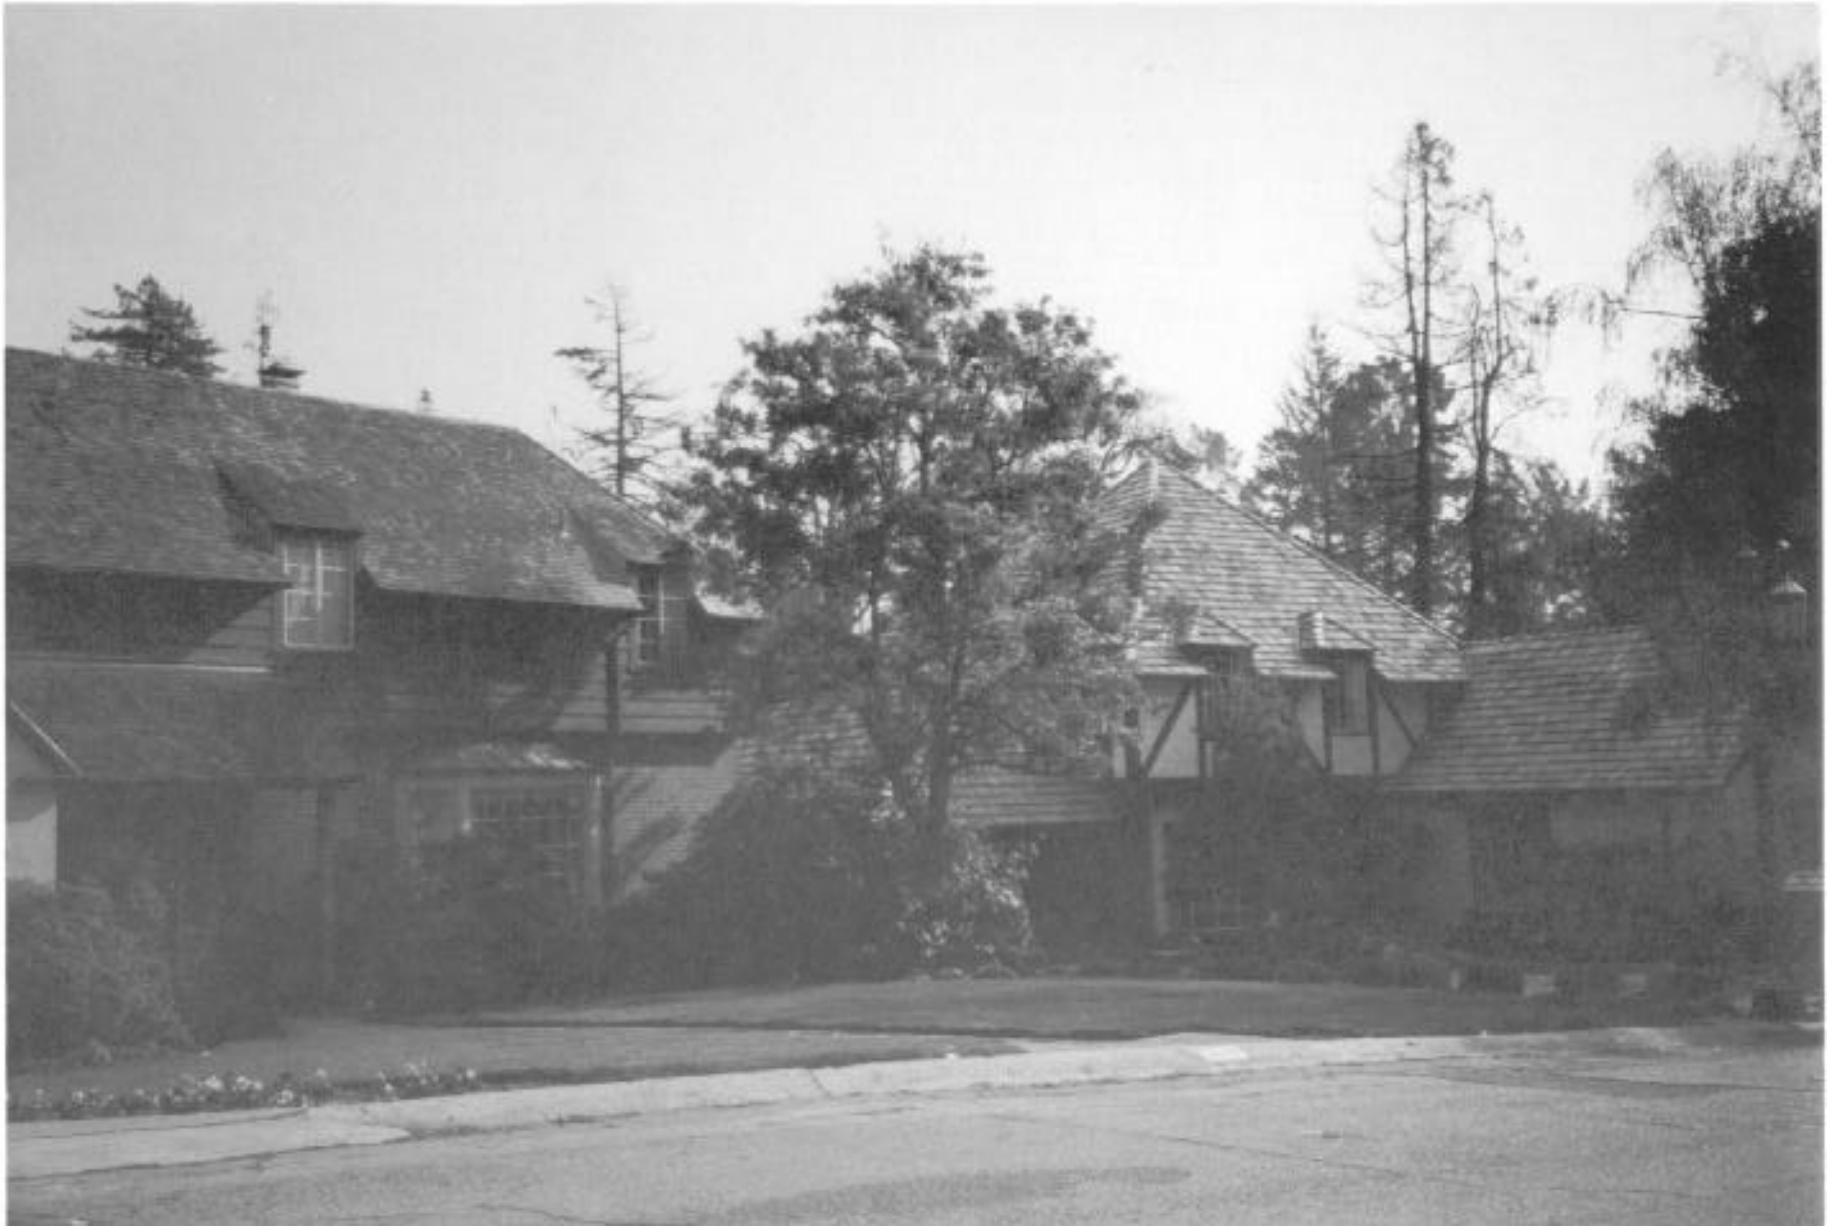
Examples of development in the fire area - wood shingle roofs.

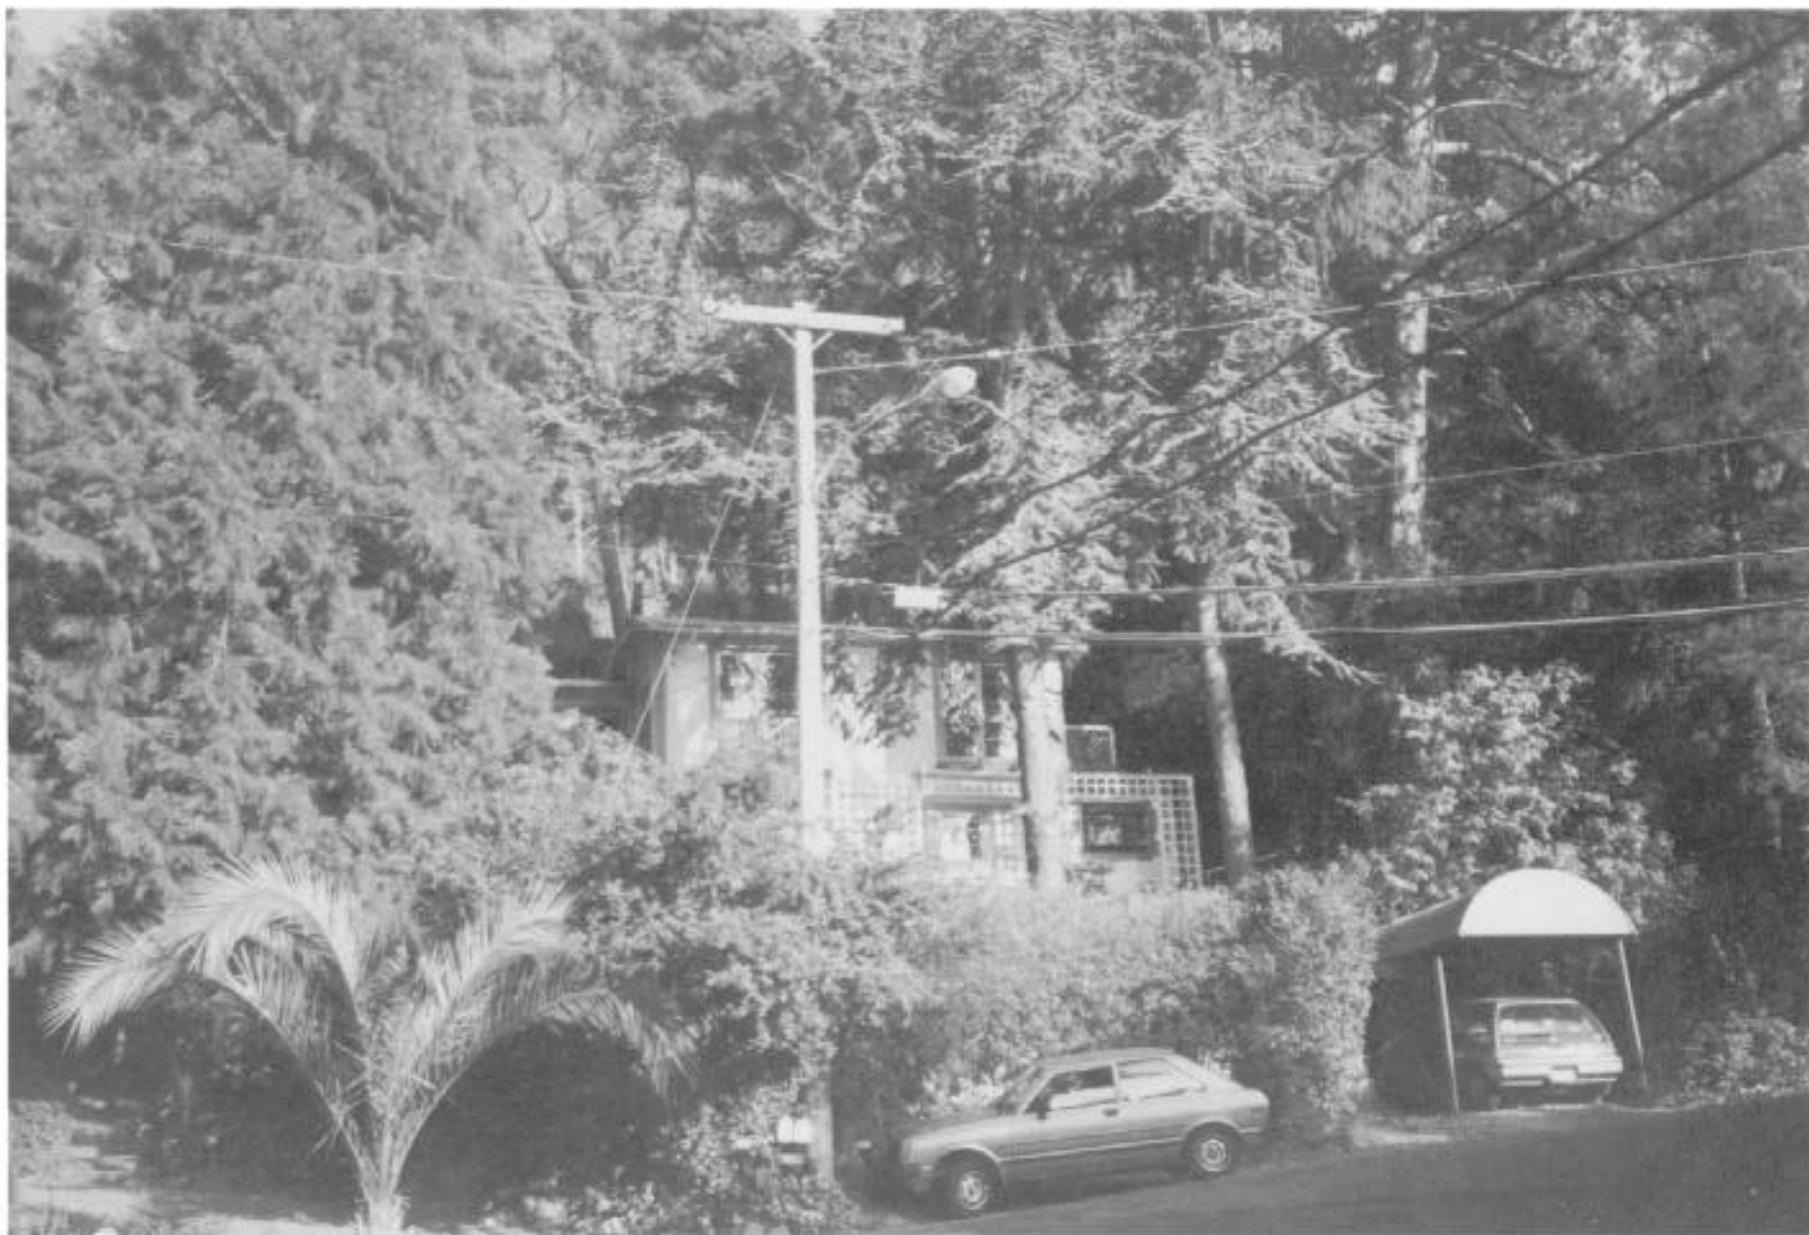
Home enveloped in natural vegetation.

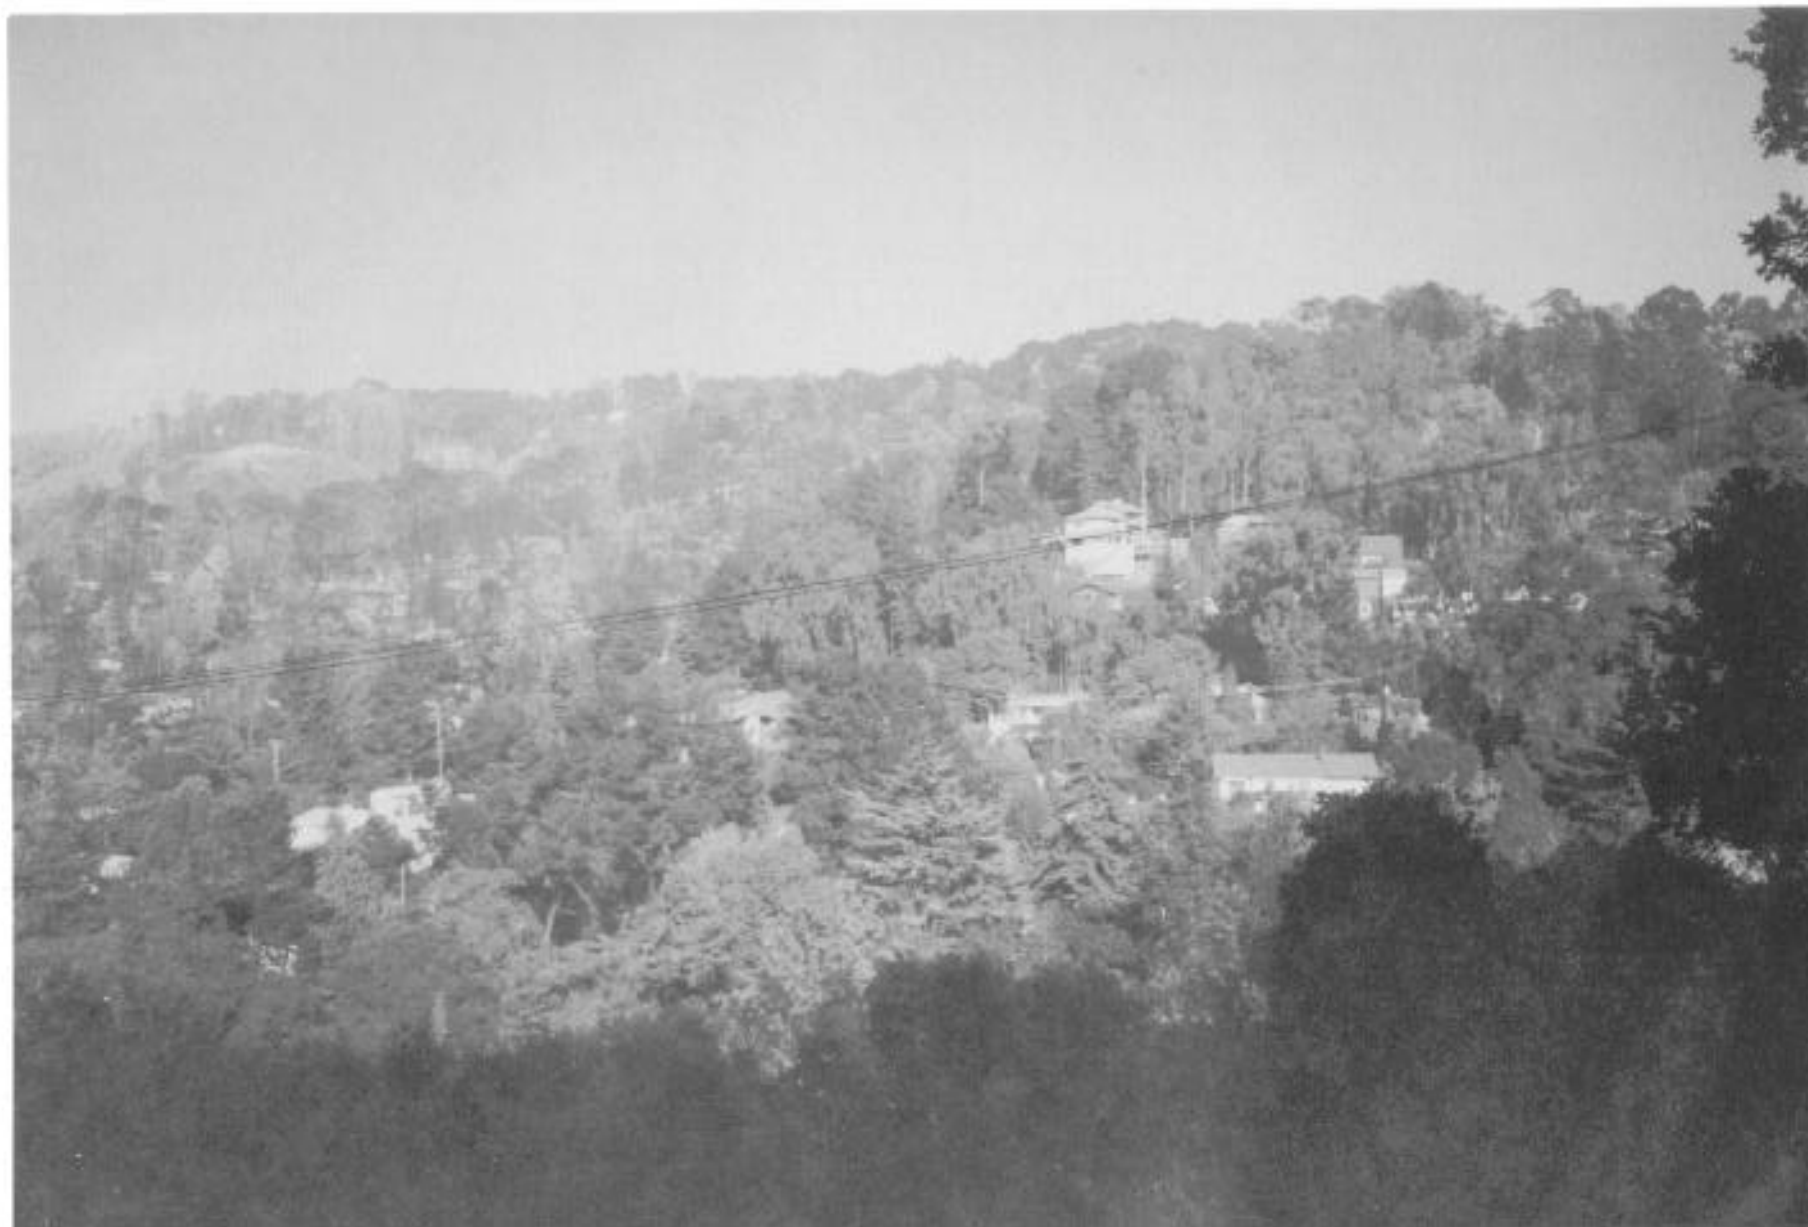
Homes enveloped in natural vegetation - fire area in background.

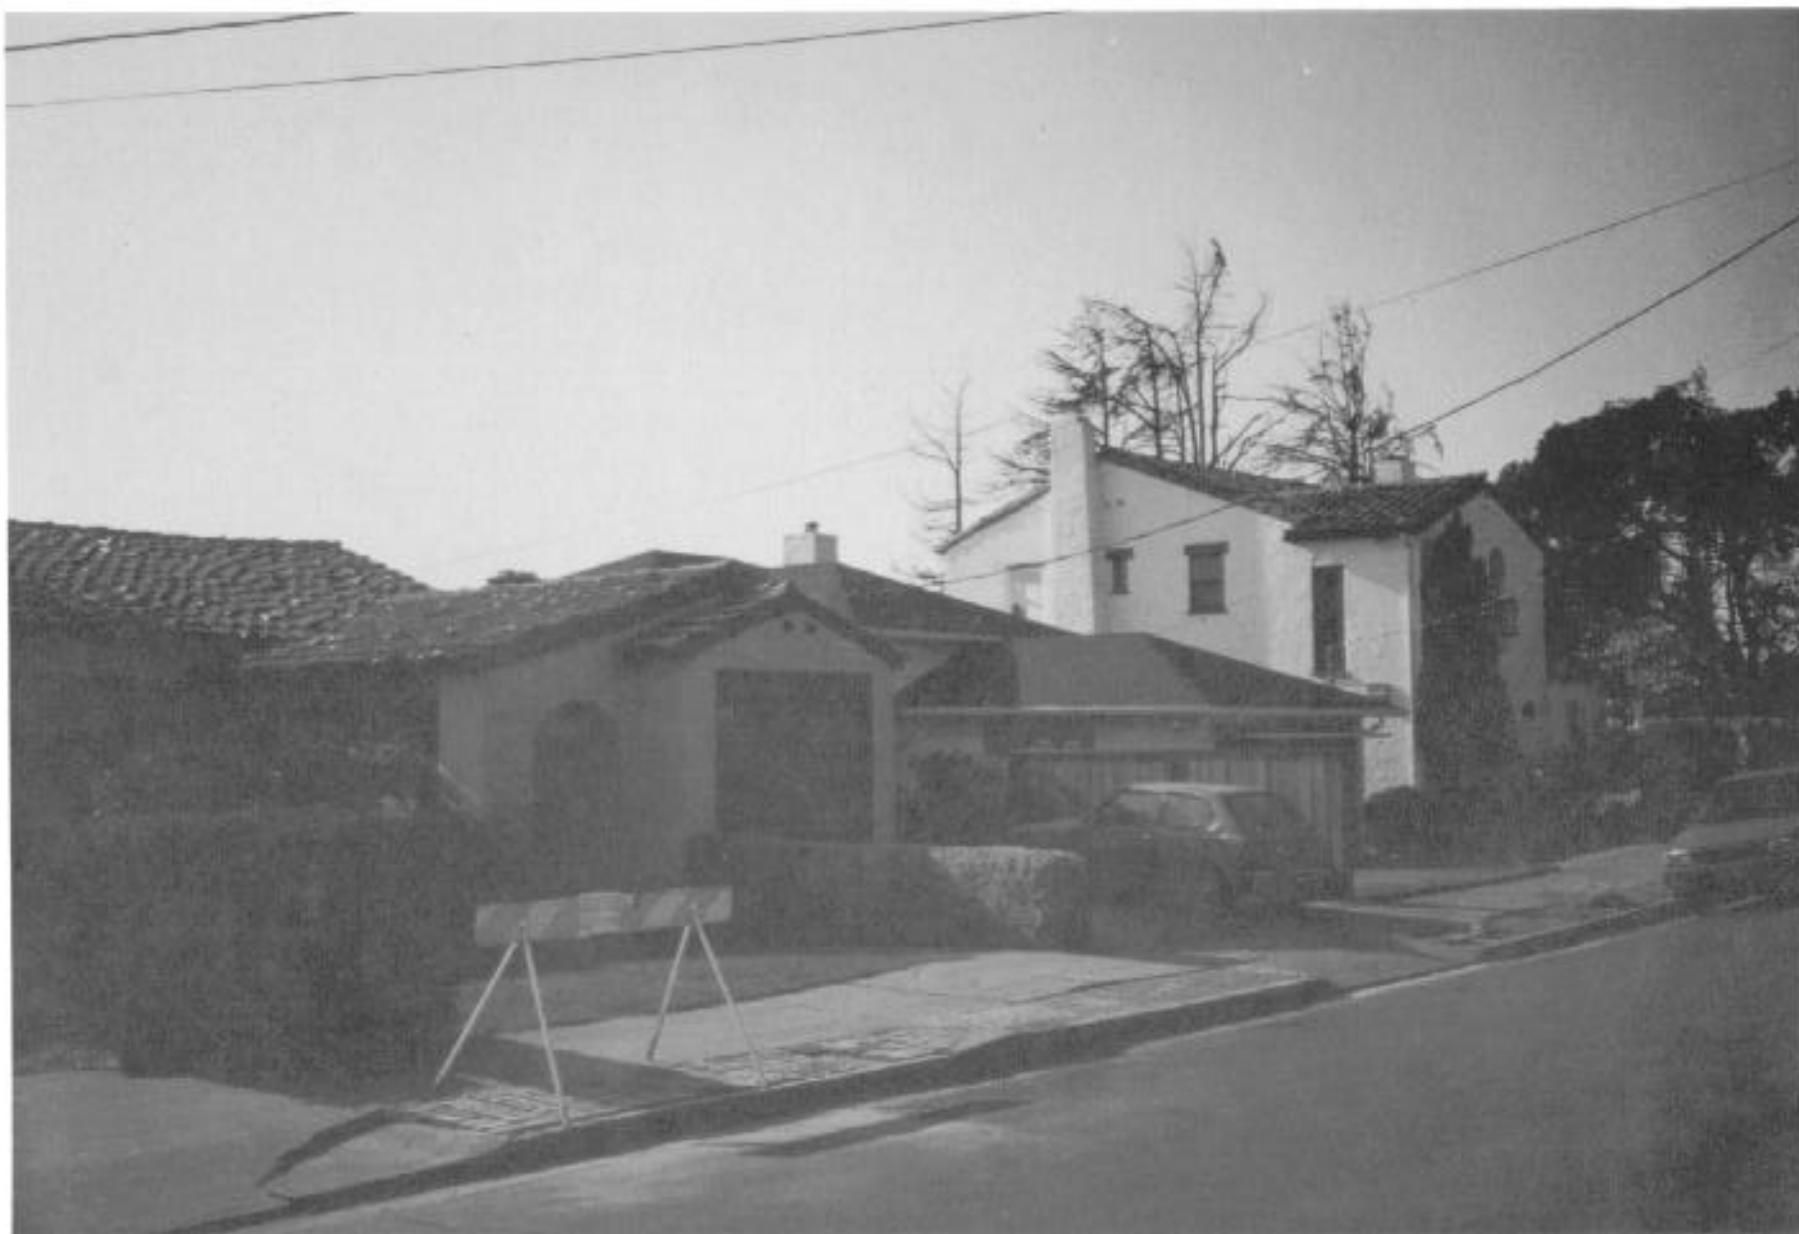
Homes saved within fire area - note non-combustible roofs.
